Manhole Inspection Summary

Manhole # S39A__039MH

Insp Date: **11/29/07 9:27 AM**

Location Address: **mcelderry st**

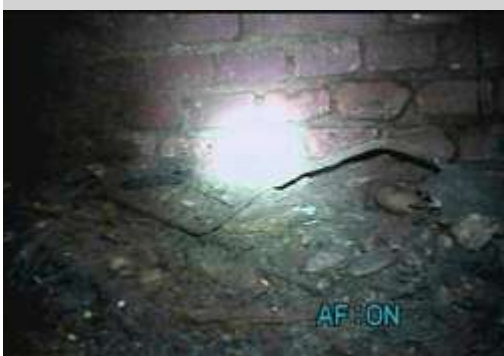
Misc.

bench debris

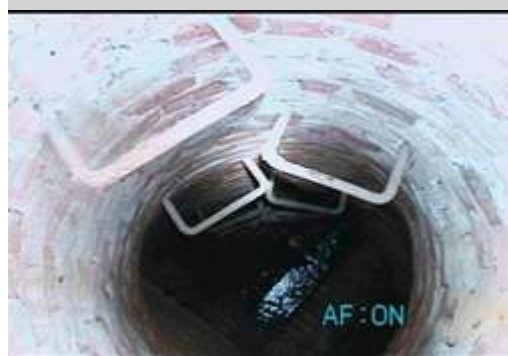
Defect 2

Steps Count: **7** Missing: **0** ☒ **Corroded**

steps

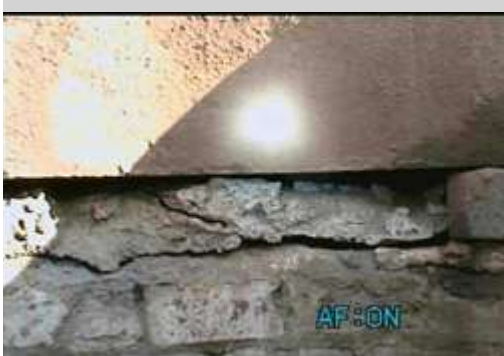
Defect 3

Condition: ☐ Sound ☒ **Cracked** ☐ Root Intrusion ☒ **Loose Brick** ☐ Deteriorated

CHIMNEY_COND_LOOSE_BRICKS

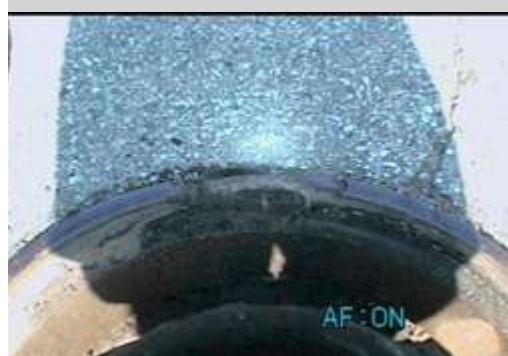
Defect 1

Frame Offset: **0** (in.) Condition: ☐ Sound ☒ **Cracked** ☐ Leaks

Frame cracked

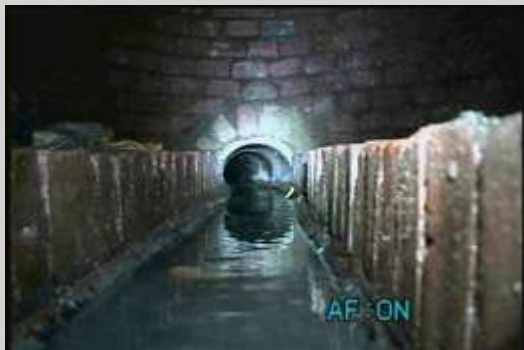
12 O'Clock Outflow

12 is under shelf couldnt get better pic

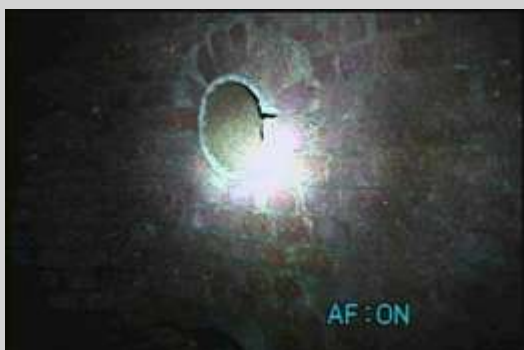
3 O'Clock Inflow

Comments **pipe at 3 is way under a shelf**

way under shelf cant get better pic
